Replace the Oil Filter Housing Gasket and Bush.

This was done on a 1995 318ti Club Sport. This has a M44 style filter housing, but the engine is a M42. Yours may be a little different, but this is what I did and it fixed the leak.

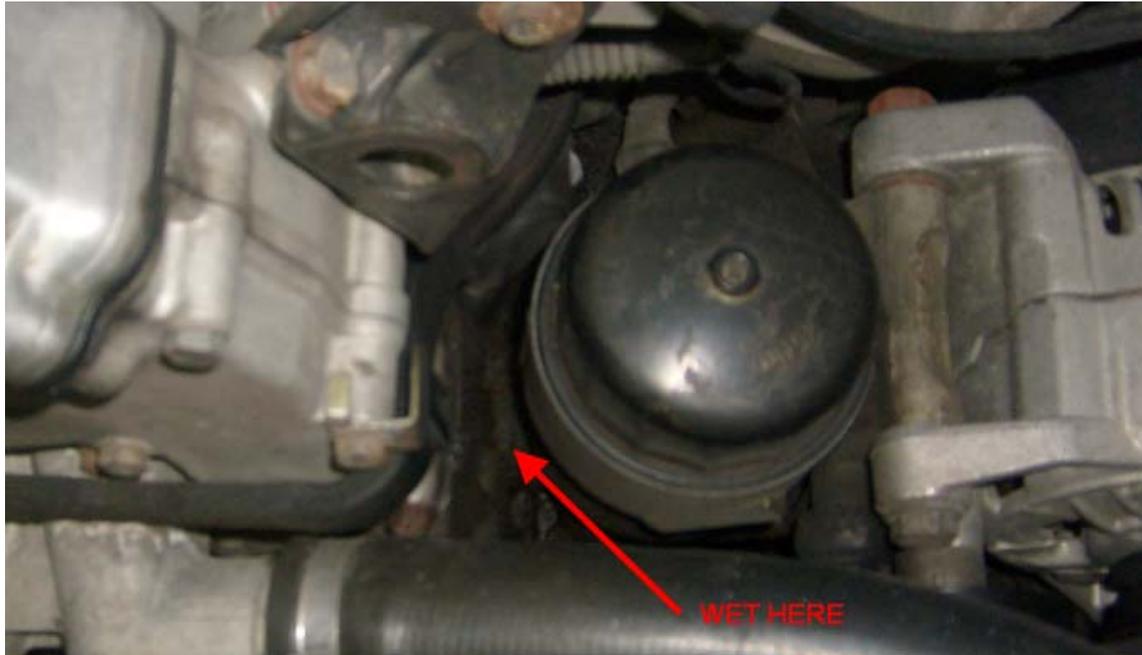
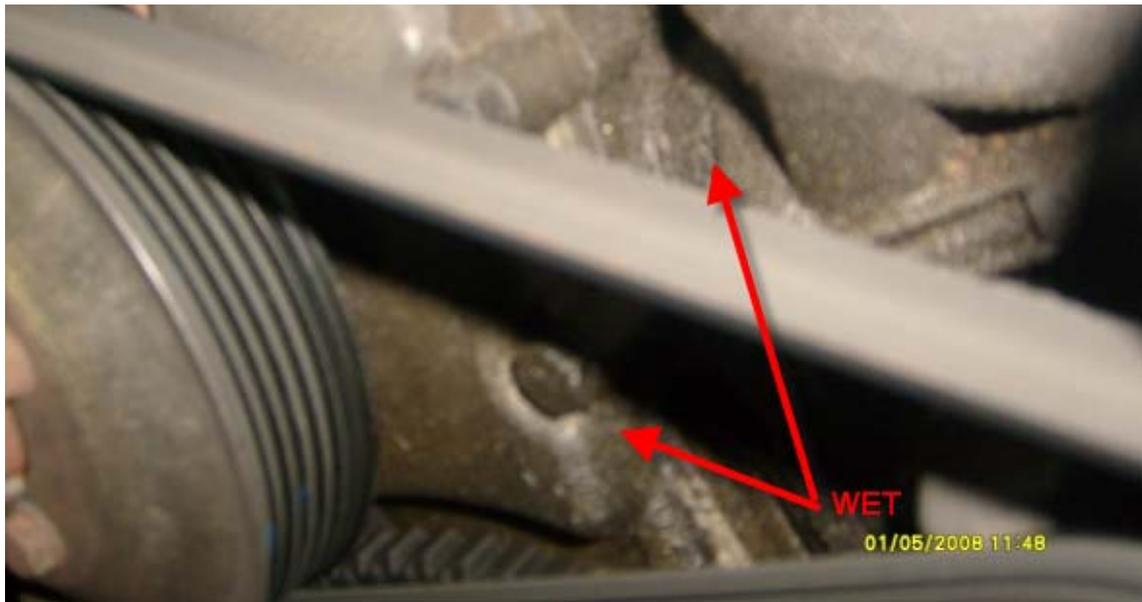
The leak looks like this:

And I got a nice burnt oil smell after driving my car... but it did not drip to the floor.

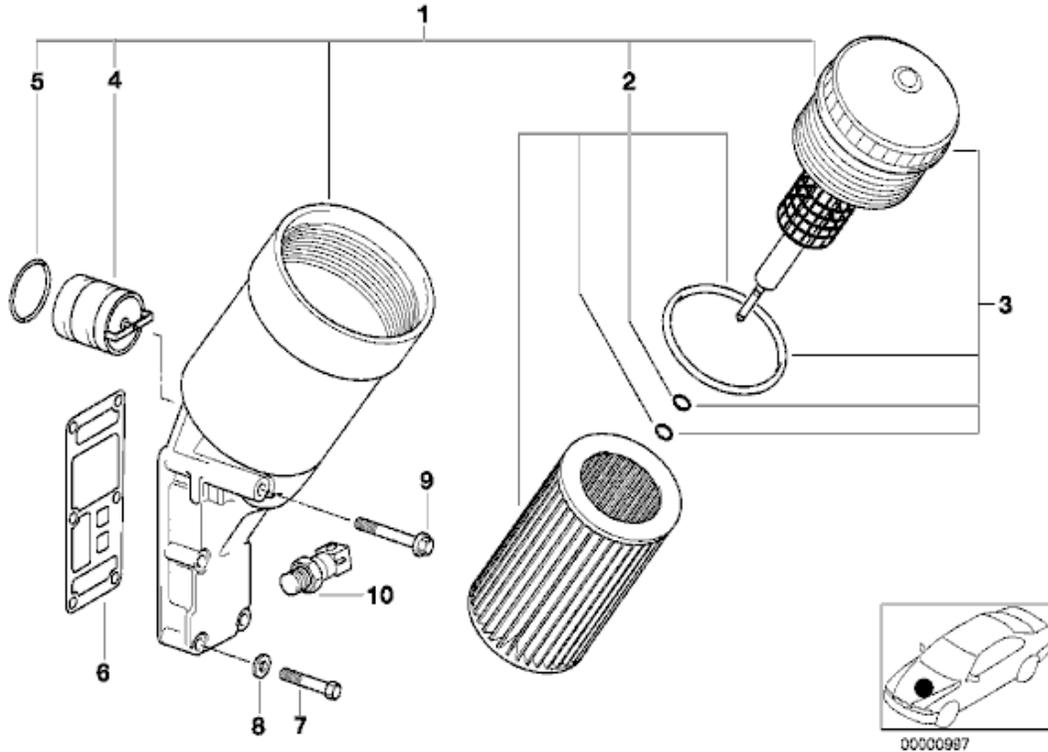
Order items 4 and 6 on the diagram below. Don't worry about item 5 (the O-rings) as they are included on the Bush.

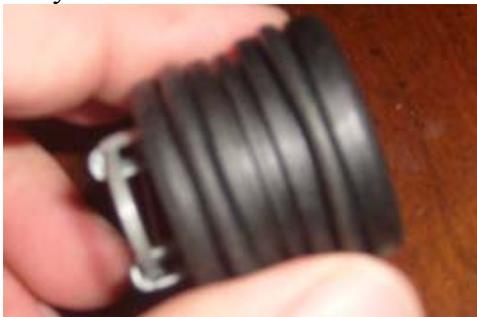
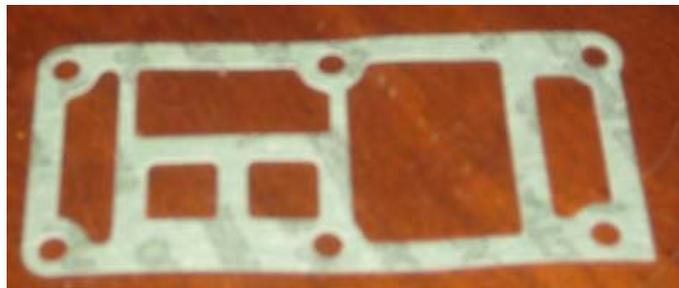
I got my parts from the dealer and it was under 11 bucks... no shipping!
They looked like this:

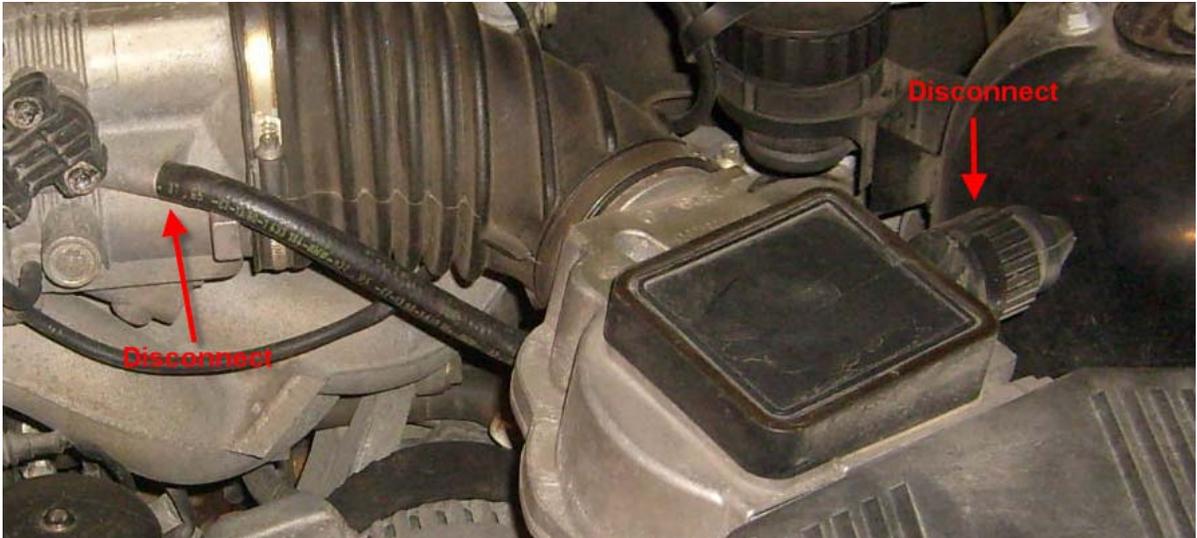
1. Disconnect the battery.
2. Unplug the wire to the Air Flow Meter (AFM) and disconnect the hose at the front on the intake manifold.

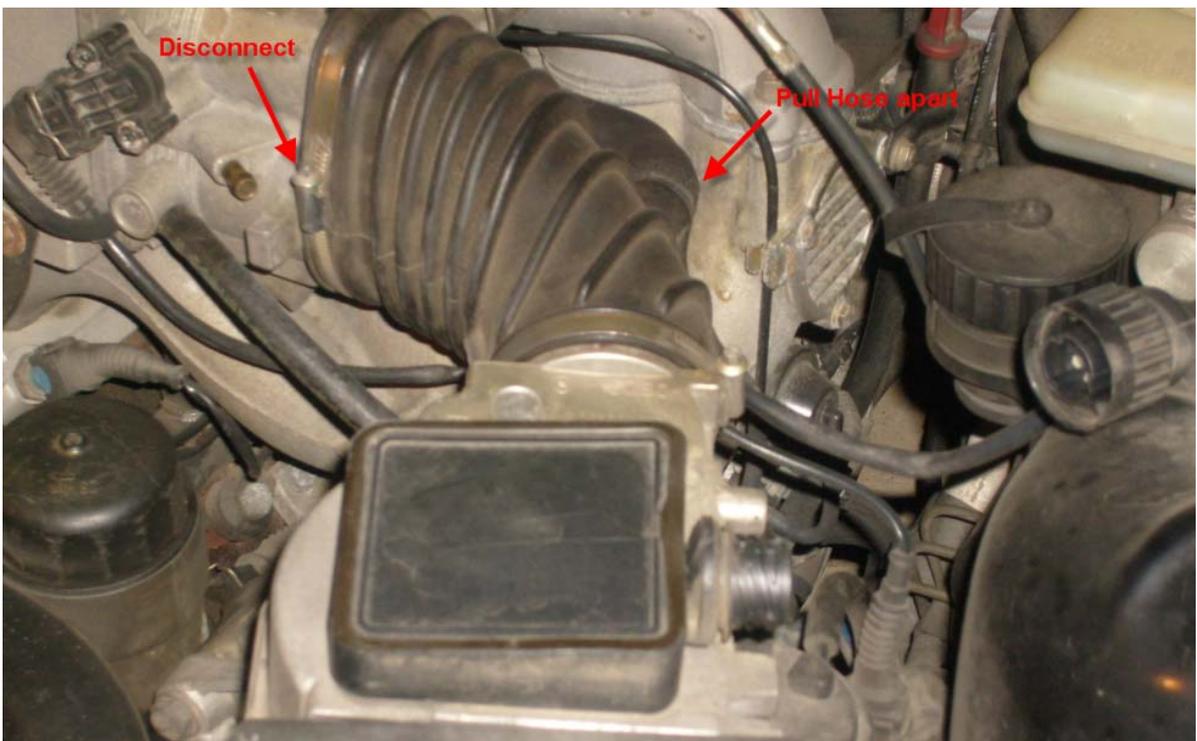
3. Remove the AFM assembly from the filter box to the Intake manifold. This is done by unclipping the top of the filter box and releasing the hose clamp at the intake manifold. You will also have to pull apart the vac hose at the back of the rubber boot.

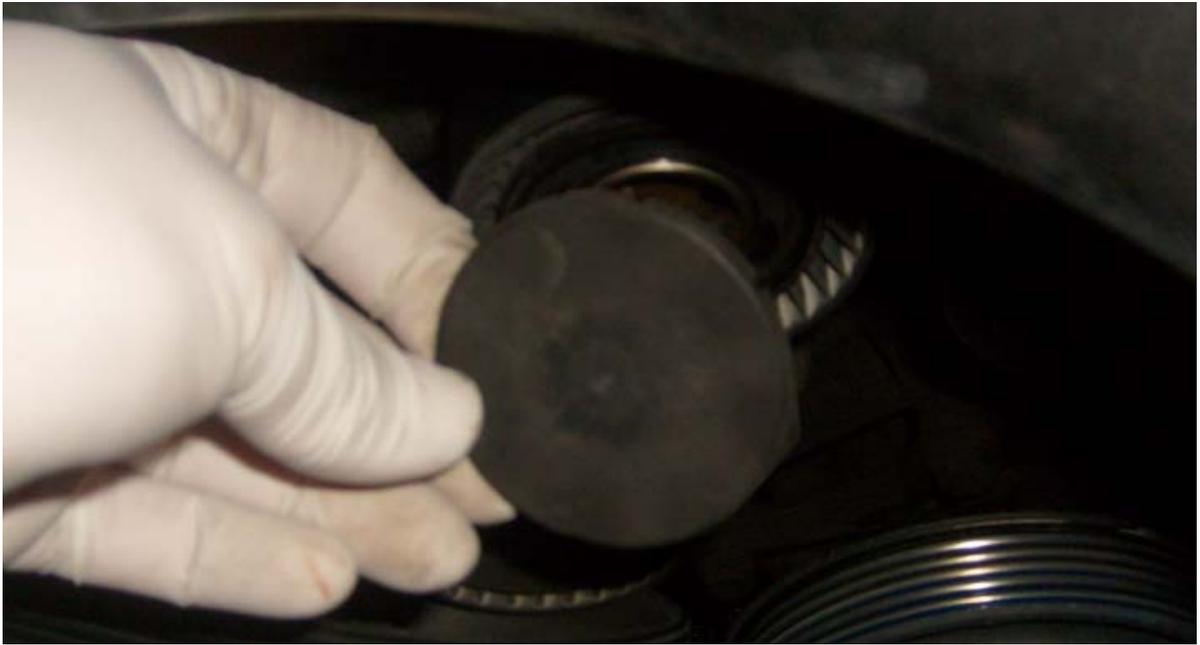
4. Use a 16mm wrench to move the tensioner pulley to the left (loosening the belt), and take the belt off of the alternator pulley.
5. Pry the rubber cover off the back of the alternator. Remove the 2 leads from their respective posts on the back. You will need a 10mm and 13mm wrench to remove the nuts. I used a ¼ drive socket to take them off... it's just the right size/shape.
6. Pry off the cap on the belt idler pulley next to the hydraulic tensioner.

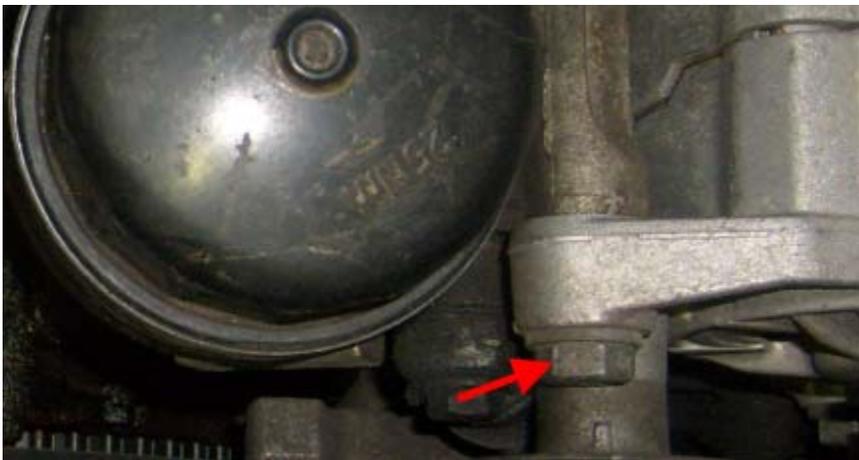
7. Remove this idler pulley by removing the screw in the center.
8. Remove the Alternator by removing the 2 screws which secure it to the bracket. One of them is shown in the picture below.

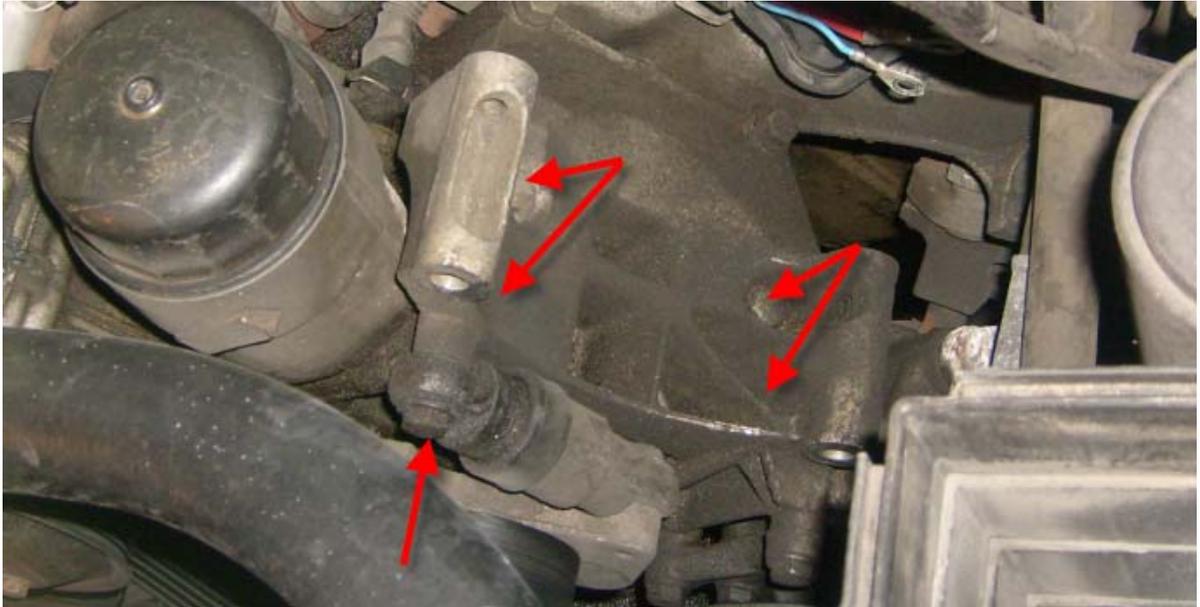
9. Pry the Alternator out of the cradle. Don't hit it with a hammer, this can kill and alternator.
10. Remove the bolt which connects the hydraulic tensioner to the cradle. Don't worry, it does not fly apart when you remove the screw. Then remove the 4 bolts which attach the cradle to the block.

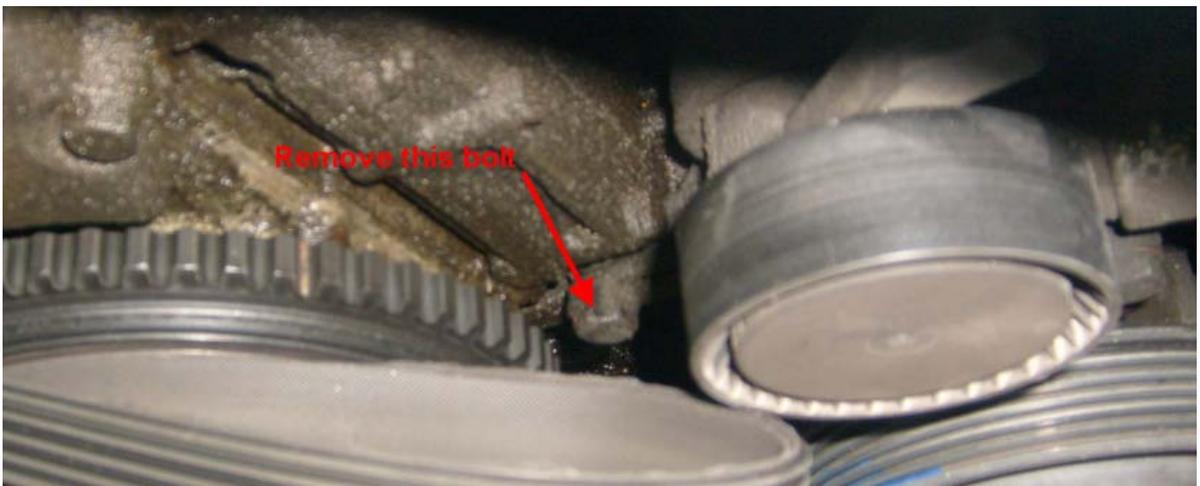
11. There is one more bolt which must be removed. It is shown in the photo below. It also holds the cradle to the block.

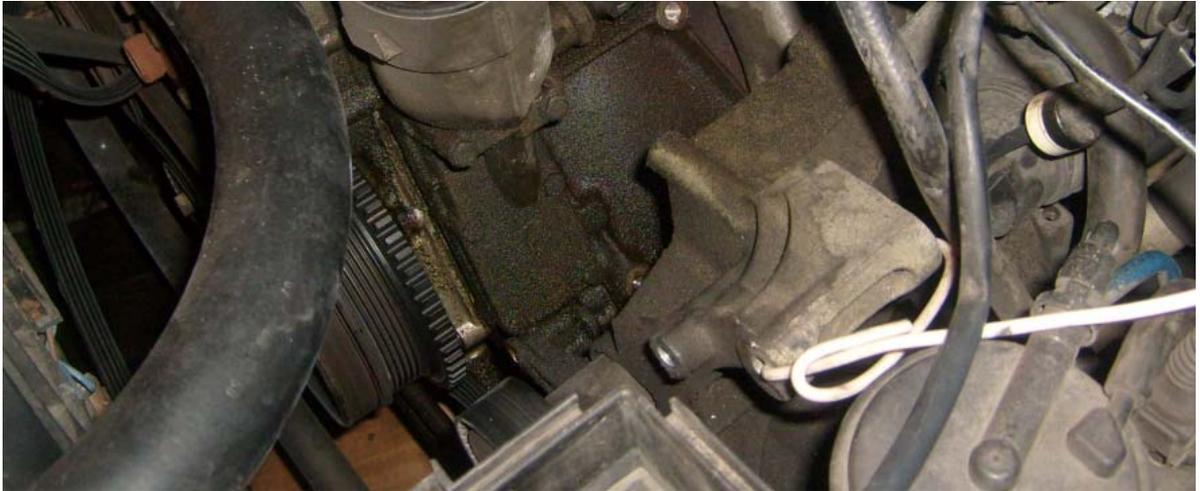
12. Since the power steering pump is connected to this cradle, too, I just held it out of the way with a wire. Be careful not to pinch the power steering lines when you do this. As you can see this leak has really made a mess of things.

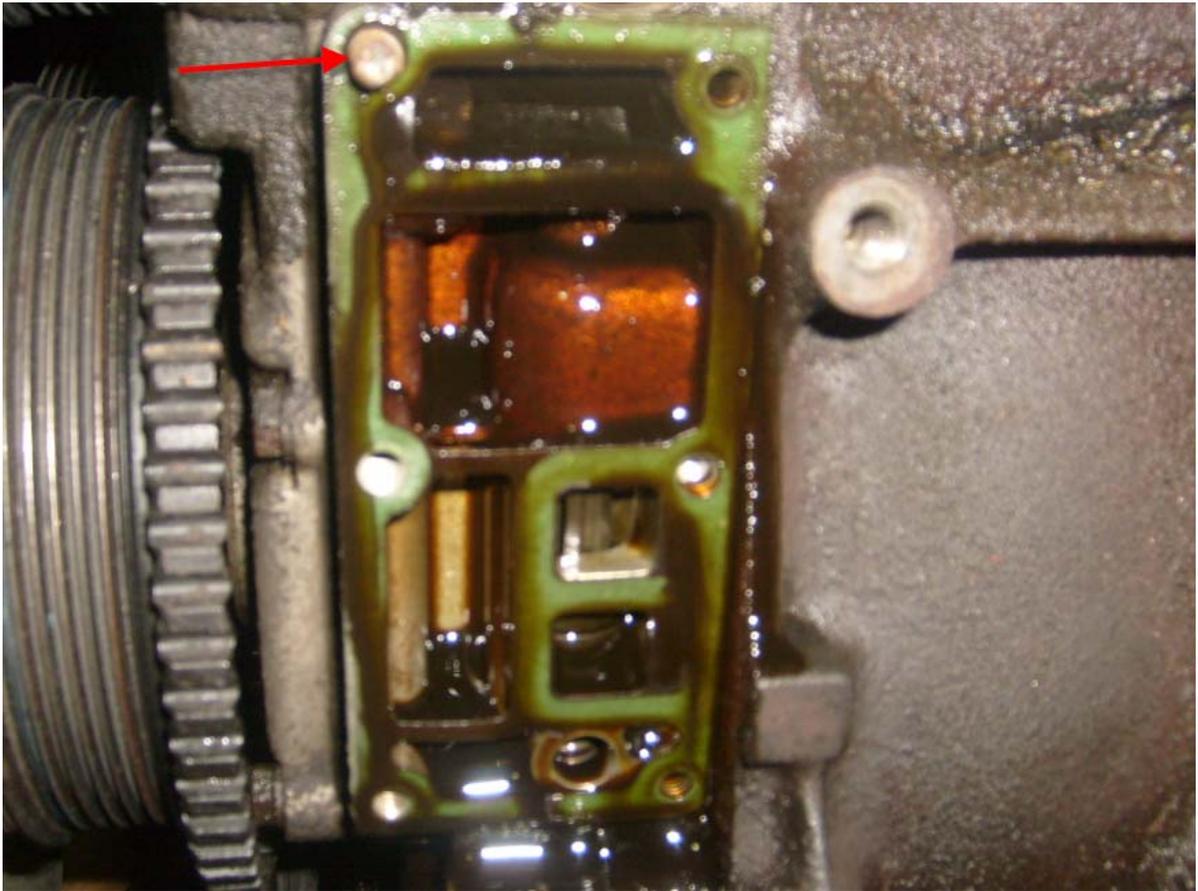
15. All this work so far was done to get at the 6 bolts which connect the filter housing to the engine. Now is the time to crack open a cold one and stare down those bolts.
16. No repair job is done without a hitch. And mine came up at this point. Maybe I stared at the bolts too long. Maybe it's a design flaw. But I could not get the top front bolt out without breaking it. It was rusted solid. If this happens to you, don't worry, you can still get the filter housing off.
17. Rock the housing back and forth to get the housing off. The bush with 2 o-rings and time are the only things holding it in place. When you get it off it will look like this. Hopefully you won't have the broken bolt shown by the red arrow, though.

18. To get the bolt out, I stuffed a rag into the openings on the engine and used a product called Freeze Off from CRC. It worked like a charm. Yes I have PB Blaster, too, but I like the idea of making it cold.
